BELZONA ALLOWS LUMBER TRANSFER ROLLS TO MAINTAIN POSITIVE TRACTION

Lumber Mill in Canada

October 1999

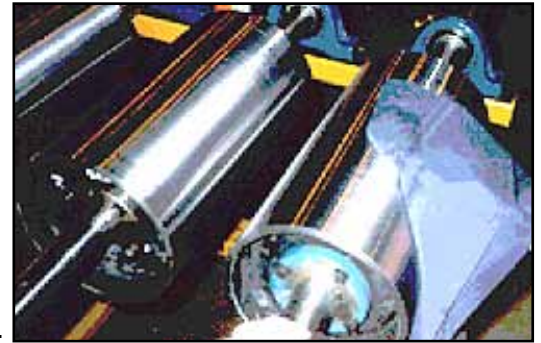
Saw mill rolls having problems firing the lumber in the correct direction creating short cuts, and crossover jams.

1. The equipment prior to the application
2. Belzona® 1321 is being applied
3. Belzona® 9211 is being broadcast onto the roller surface
4. The aggregate is being tamped
