BELZONA RESTORES AND PROTECTS HISTORIC BATTLESHIP, NOW A FLOATING MUSEUM

327-Foot High Endurance Cutter - USCG Taney

Badly corroded hull at and below the waterline.

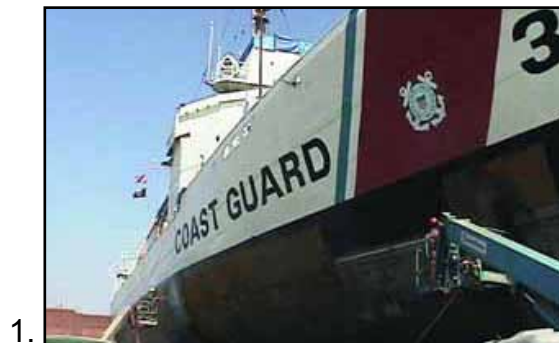
1. An overview of the USCG Taney
2. Hull corrosion is clearly evident
3. Belzona® 1111 is being finished
4. The Taney has been repaired, and is ready to go back in the water

The Taney is the last remaining warship afloat that survived the attack on Pearl Harbor. She now serves as a floating museum in Baltimore Harbor. Belzona® 1111 was used to fill in badly corroded areas. Following this an 18" band around the entire ship was protected with Belzona® 5811.
