BELZONA® 3111 FLEXIBLE MEMBRANE SEALS SKYLIGHTS - FINALLY!

University, BC, Canada

Patented aluminum skylights

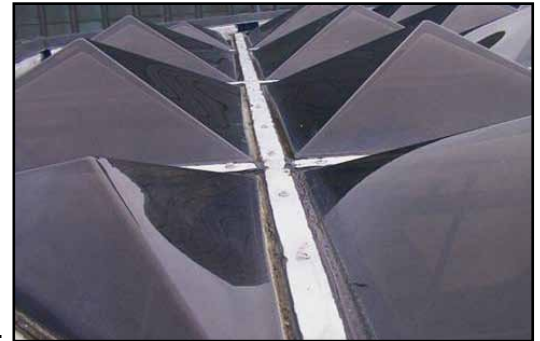
The skylights were situated over a major gathering area and presented a constant maintenance problem for many years. The leaks also created major safety issues and other problems

1. View of skylights showing roof design and gutter detail.
2. A close up of one of the many problem areas
3. Completed application
