BELZONA PROTECTS CEMENT PACKING MACHINE STEEL PLATES

Cement Works, Usje, Macedonia

Steel plates and steel seats of a cement packing machine.

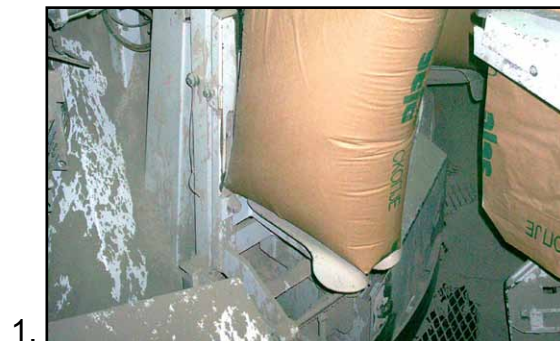
1. Cement packing machine.
2. Condition of the coated steel plate and steel seat after one year in service. (Experiment which shows no wear after one year).
3. Repaired seats and sheets.

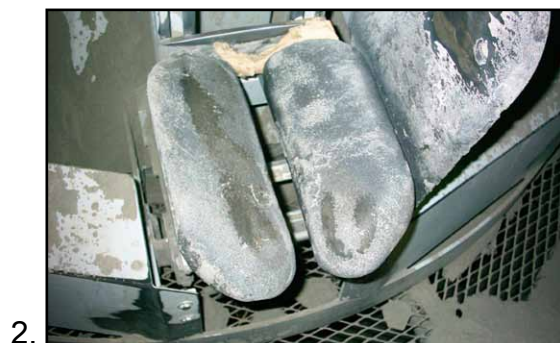
Initially done as an experiment, the cheapest base metal was chosen and coated with Belzona. One year later the plates were inspected and were found to have suffered from no wear at all. Belzona® 1812 would be expected to give similar results.

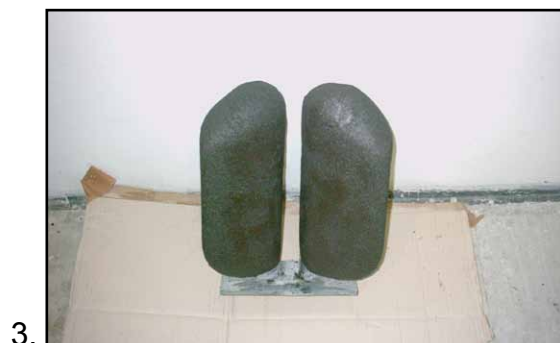
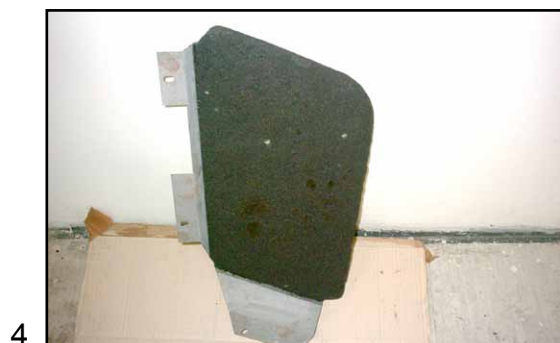
Deterioration of the steel plates and steel seats due to wear from the cement bags.

Belzona® 4811 (Magma AR Screed)

Application was carried out in accordance with Belzona Know-How System Leaflet SHM-13.
