## BELZONA PROVIDES OPTIMISED SOLUTION FOR BEARING INSTALLATION

UK (Cornish) Luxury Yacht Builder

Installation of bearings into the stern tube housing

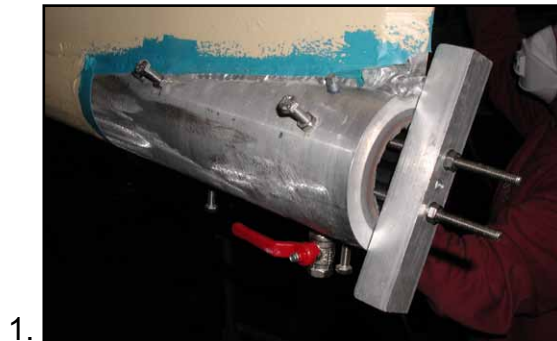
1. Bearing aligned. Note the injection port with valve under the housing.
2. Forward inboard view of stern tube.
3. Completed application.

The application was carried out using a modified version of Belzona Know-How System Leaflet SOS-9. The bearing housing is grit blasted and the bearing rough turned prior to alignment and injection of the Belzona® 1321. Belzona® 9411 was only used on the alignment bolts to allow their later removal.
