BELZONA WEATHERPROOFS INSULATED ROOFTOP DUCTING

Ivy League Medical School

Heated and cooled air roof top ducts.

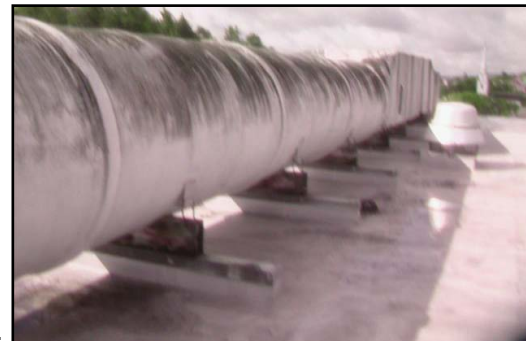
Original protection no longer water-tight. Insulation was wet and water was leaking into the building. CUI was feared.

1. Degraded insulation on ducts
2. Degraded insulation at building interface
3. Recoated and protected with Belzona
4. Summer 2007 still as good as new!

The original plan was to remove all wet existing insulation and re-insulate and waterproof over 200 feet of 60 inch carbon steel ducts. Micro-porosity of Belzona system allowed existing insulation system to dry out so restoring protection and efficiency. System still excellent 3 years on.
