BELZONA REPLACES ACID BRICK

Refinery, North Alabama U.S.A.

New curbing was installed on a pad where acid brick was previously used.

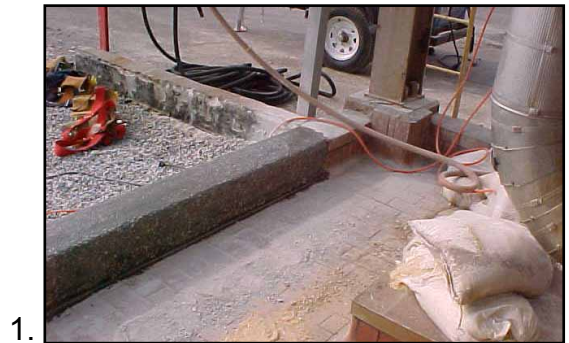
1. Applying Conditioner to the curbs
2. Troweling the Belzona® 4181
3. Application underway
4. Finished project
