BELZONA PROVIDES SAFE LANDING PAD

Hospital Heliport, Wyoming U.S.A.

Helicopter pad measuring 6000 square feet on top of the hospital parking structure.

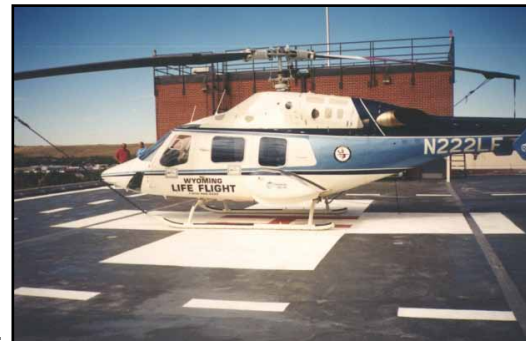
1. Helipad completed August 1999
2. FAA Weight Limit Marking August 1999
3. FAA Weight Limit Marking August 2008
4. Helipad After 9 Years of Service August 2008
