## BELZONA PROTECTS RISER IN SPLASH ZONE

Offshore Platform, Adriatic Sea

Riser splash zone from the rubber boot to approximately 3.0m above the water

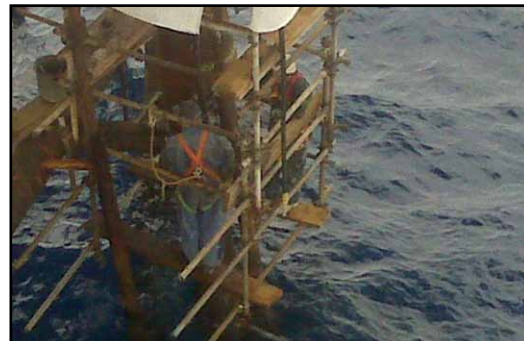
1. Surface preparation by grit- blasting
2. Washed application area following blasting
3. Applying first coat of Belzona® 5831
4. Applying second coat of Belzona® 5831

The application was carried out in accordance with Belzona Know-How System Leaflet SOS-21. Surface preparation by grit-blasting (garnet) followed by two coats of Belzona® 5831 applied to the area.
