STRESS FREE SEALING OF THREADED PIPES WITH BELZONA

Telecom company, Montreal, Canada

Sealing threaded pipe joints.

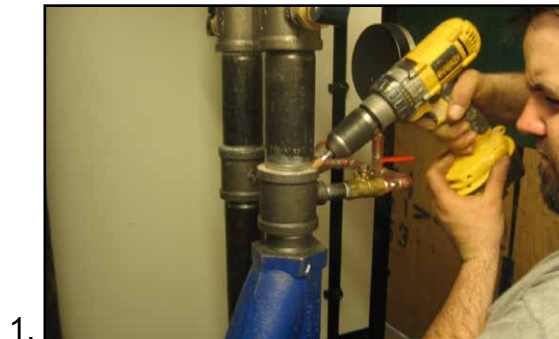
1. Surface preparation of pipe
2. Application of Belzona® 1121 with brush
3. Finishing the application neatly
4. Completed application
