## BELZONA GIVES SUPPORT TO NEW RAILS OF 10 TON PRESS

7 metre long support rails for 10 ton press in Drywall panel production plant

Irregularities in underlying steel base gave requirement for an irregular shim of between 2 & 10mm for new steel support rail for the press.

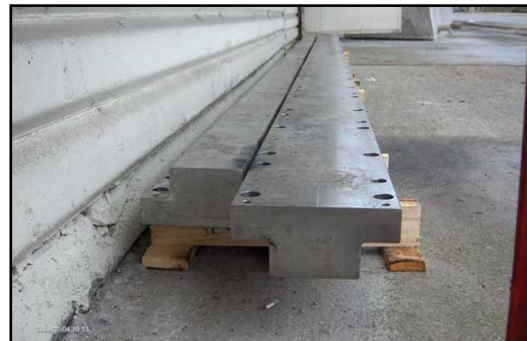
1. View of new stainless steel rails.
2. After surface preparation and dry fit assembly Belzona® 1111 applied to seal around rail perimeter
3. Creating irregular shim by injection of Belzona® 1321
4. Completed repair and press ready to be lowered into position
