BELZONA PROTECTS RIVER TEES

Financial Sector, Teesside, UK

Riverside Bunds for Generators and Oil Storage

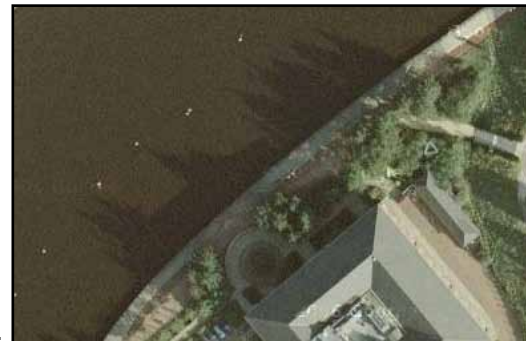
1. Riverside location of the office facilities
2. Generator room during application with covings completed
3. Generator room completed

Application was carried out in accordance with Belzona Know-How System Leaflet TCC-15. Covings and fillets were formed with Belzona® 4131 and Belzona® 4141 prior to sealing area with Belzona® 5811.
