BELZONA PROTECTS 35 GATE VALVES FOR REFINERY

Petrochemical Company, Sultanate of Oman

35 new valves acquired for expansion of plant. These valves control the flow of sea water into the plant

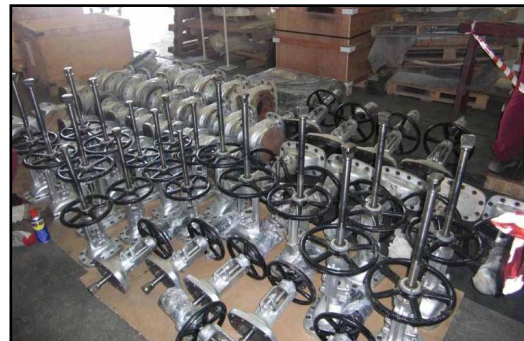
1. Valves open for inspection
2. Internal surfaces grit blasted
3. Belzona® 1341 application complete after applying 2 coats
4. Assembled valve undergoing pressure test
