## BELZONA HELPS PLATFORM QUALIFYING FOR PLUG & ABANDON PROJECT

Offshore operator had six wells that had to be pressure tested to 500 PSI to be qualified for Plug & Abandon (P&A) Program.

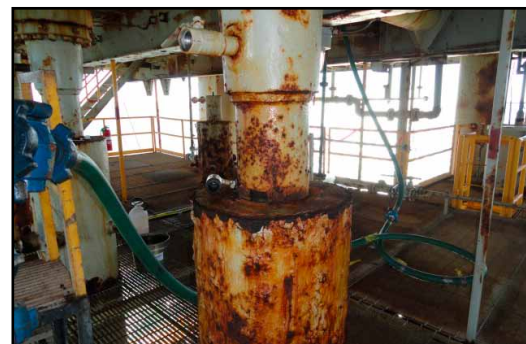
External/Internal corrosion caused many hole through defects. Conventional welding would have been very time consuming and expensive. Additionally, a hot work repair would have caused shut down of the platform resulting in a great loss of production and income.

1. Well conductor showing external corrosion.
2. Building fillet with Belzona 4141.
3. Installing Belzona 1121/Belzona 9371/Belzona 4151.
4. Completed Belzona Composite Wrap.
