BELZONA PROTECTS CONCRETE FROM 50% CAUSTIC SOLUTIONS

Textile Company, São Paulo, Brazil

50% Caustic solution unloading bay.

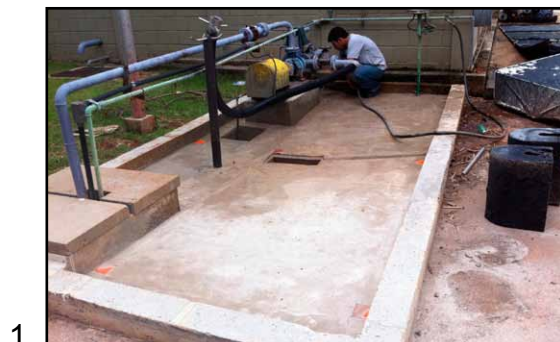
50% Caustic solution containment area coating had failed and needed re-coating.

1. Area to be coated.
2. View of drain.
3. Coating of Belzona 5891.
4. Completed application.

The application was carried out in accordance with Belzona Know-How System Leaflet TCC-15. Concrete was rebuilt and application of Belzona 5891 was complete with one coat.
