BELZONA COATS FLOORS FOR PROTECTION AGAINST CHEMICAL ATTACK

Burlington, ON, Canada

Garbage room floors in a mall.

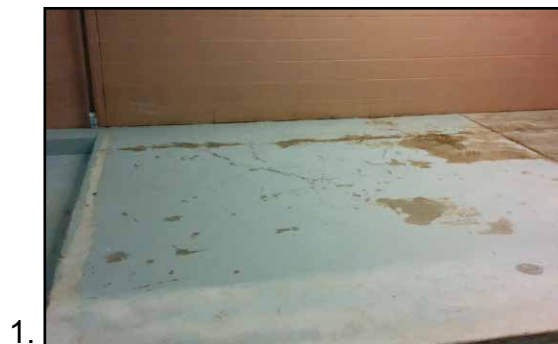
Waste was causing chemical attack so the customer wanted a coating to protect the flooring.

1. Prior to application
2. Preparation in progress
3. Completed application
