## BELZONA OFFERS SLIP RESISTANT COATING ON STAIRCASE

Staircase access to car park.

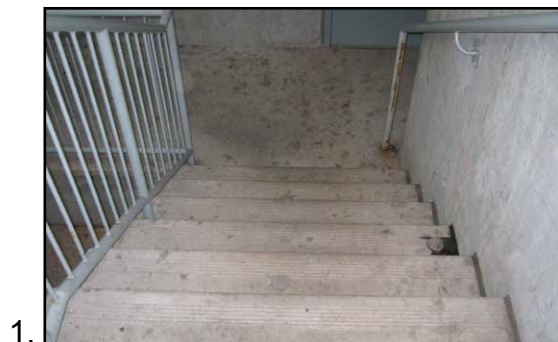
1. Prior to application
2. Completed application
3. Completed application

The application was carried out in accordance with Belzona Know-How System Leaflet FPA-3 for protecting floors and drains against chemical attack. The surface was prepared by power washing the surface to remove dirt, debris and salt contamination. A diamond grinder was used to abrade the surface and remove small floor imperfections. Belzona 5231 was applied for the first coat and Belzona 9221 was broadcasted for increased anti-skid properties. A second coat of Belzona 5231 was applied within the overcoat window in accordance with Belzona Instructions For Use.
