LOADING DOCK DRAIN COATED WITH BELZONA

Loading dock drain.

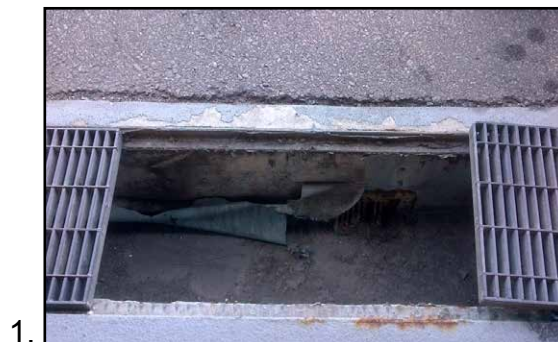
The existing coating had failed, causing blockage of the drain.

1. Prior to application
2. Preparation in progress
3. Application in progress
4. Completed application
