BELZONA PROTECTS PARAPET WALLS FROM WATER PENETRATION

Parapet walls of a condominium building.

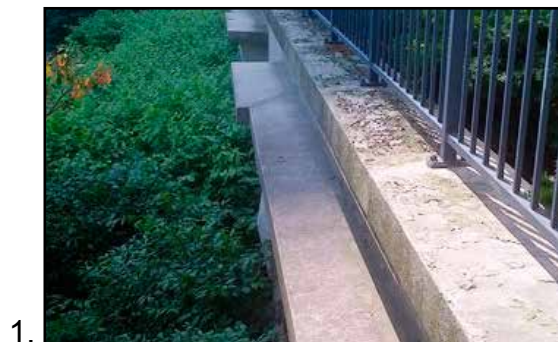
Water was penetrating the concrete.

1. Prior to application
2. Application in progress
3. Completed application
