BELZONA PROTECTS NEW HEAT EXCHANGERS

Industrial treatments company, Barcelona, Spain

Heat exchangers working with salty water.

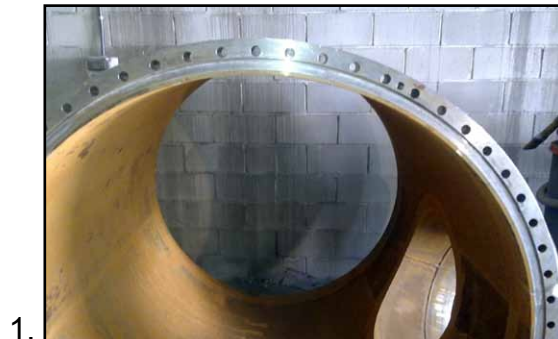
1. Part to be coated, before blasting
2. Coating with Belzona® 5891
3. End heads coated with Belzona® 5891
4. Cover coated with Belzona® 5891
