FOUR LARGE CONDENSERS PROTECTED WITH BELZONA

Nuclear power plant, Jaslovské Bohunice, Slovakia

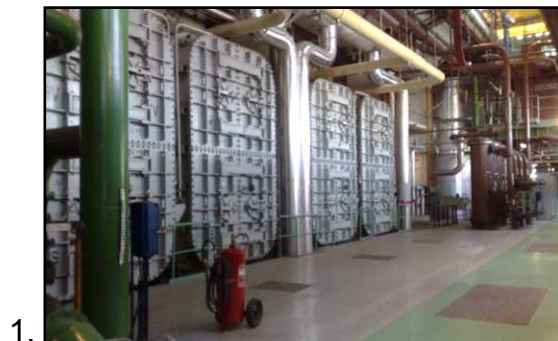
1. 1 condenser 4 boxes on one side
2. Before reconstruction
3. Test for the surface contamination
4. Tubesheet and water boxes protected with Belzona
