INVISIBLE BELZONA PROTECTION FOR CHAPEL

Parapet Walls on Crematorium Chapel of Remembrance

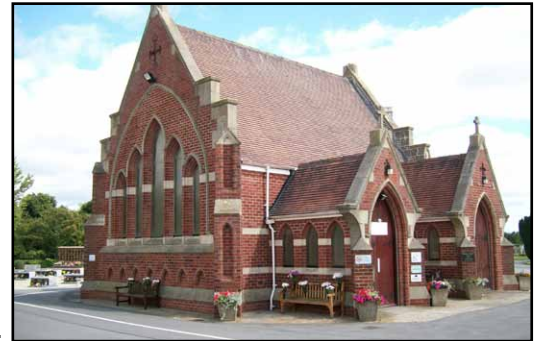
1. Chapel of Remembrance - Front
2. Chapel of Remembrance - Rear
3. Parapet Wall Sections Protected with Belzona® 5122

Application was carried out in accordance with Belzona Know-How System Leaflet WPA-8. Once the brickwork had been repointed, all parapet wall areas were protected with a single coat of Belzona® 5122.

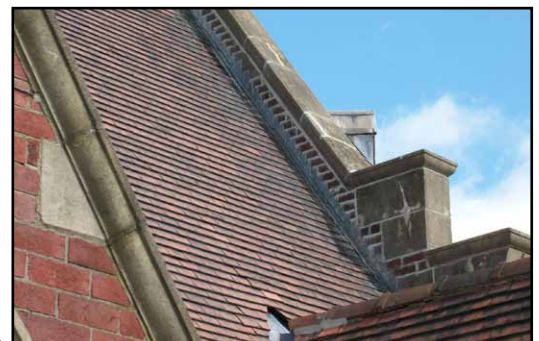
Aging mortar for masonry and brickwork had become porous. Water was persistently penetrating the structure, creating damp areas on internal walls. The Council wished to retain the original appearance of the structure.
