BELZONA PROTECTS DESULPHURIZATION UNITS

Desulphurization unit, Powerplant, USA

Exhaust gas ducts of a smoke processing unit.

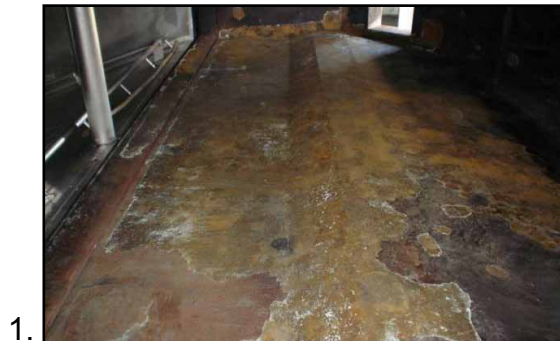
1. Before the application
2. Application of Belzona® 1391
3. Completed Application

Corrosion by sulphurous gases at high temperatures.
