## DISCHARGE PIPES PROTECTED WITH BELZONA

Phosphate plant, Mohammedia, Morocco

1200mm diameter discharge pipes

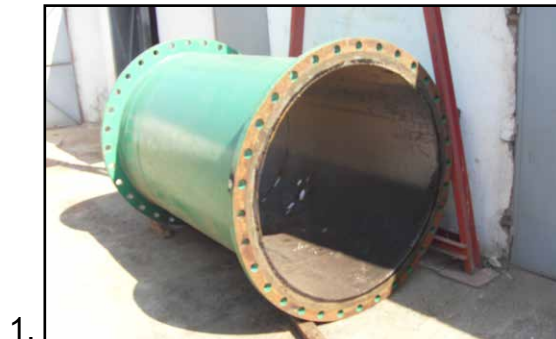
1. Original pipe
2. Gritblasted discharge pipe
3. Application in progress
4. Completed application
