## BELZONA MAKES MESSY JOB EASY CLEAN

Construction company, Toronto, ON

May 2012

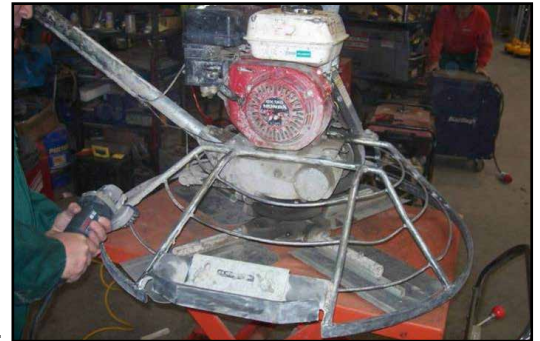
1. Surface preparation
2. Brush Application of Belzona® 1341
3. After application and first usage
4. Simple cleaning with power washer

Application carried out in accordance with Belzona Know-How System Leaflet VPF-2

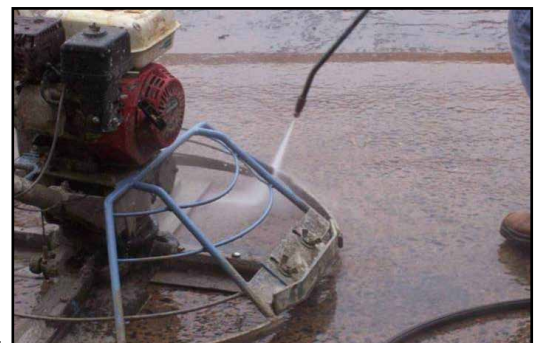
4.

The application of Belzona® 1341 has reduced cleaning time by 900-1200%. It now takes just 5 minutes and only requires a power washer!
