BELZONA LOW ODOUR SOLUTION FOR TRAINING COLLEGE ROOF

Police Training College, South East England

Roof over Police Training College.

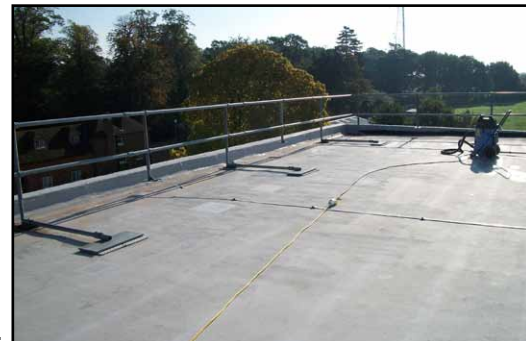
1. The roof being washed down ready for the repairs and coating
2. Preparation completed and the Conditioner being applied
3. First and second coats of Belzona® 3111 completed
4. Completed application of Belzona® 3111 system

Application was carried out in accordance with Belzona Know-How System Leaflet RPA-8. Damage in the asphalt was repaired with Belzona® 4111 before the complete roof was sealed with a fully reinforced Belzona® 3111 System.
