BELZONA STABILIZES GAS PIPELINE ON BRIDGES

Gas transmission company, Slovakia

Pipe bridges supporting gas pipeline over waterways

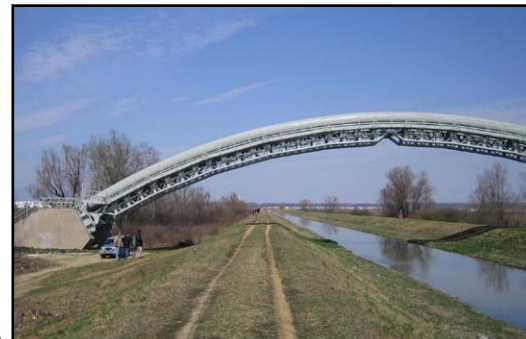
1. General view of pipe bridge
2. Preparing/measuring location for supports
3. Belzona® 1111 used to bond wear pad
4. Completed sliding support in place
