## BELZONA PROTECTS NEW PROCESS VESSELS FOR GAS PROJECT

3 Feed gas liquid separators constructed for new gas project

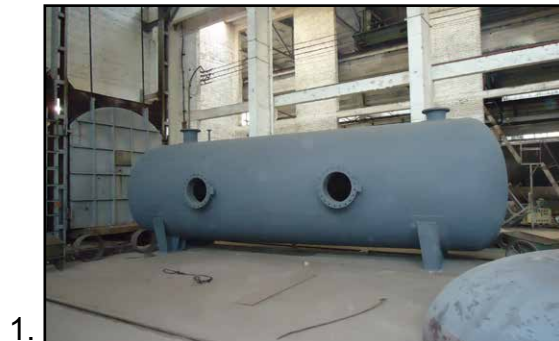
1. General View of Vessel
2. Vessel prior to grit blasting
3. Application underway
4. Application completed
