BELZONA SEALS & WEATHERPROOFS ASBESTOS SCHOOL ROOF

School, Galashiels, Scotland

Approximately 500 m² asbestos roof on a school building.

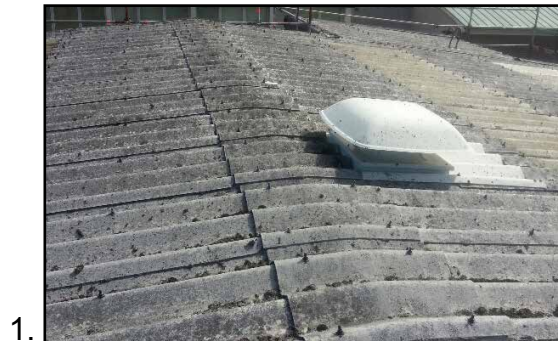
1. Before power wash
2. After surface preparation
3. Applying the Belzona® 3111 Membrane system
4. Finished section of roof

Application was carried out in accordance with Belzona Know-How System Leaflet RPA-1. The roof was power washed with a special filter system used to collect the 'run off'. Belzona® 3111 system was then applied to the entire roof area.
