## COMPLEX ROOF WEATHERPROOFED WITH BELZONA

Boarding school, SW England

School boarding house roof with complex geometry.

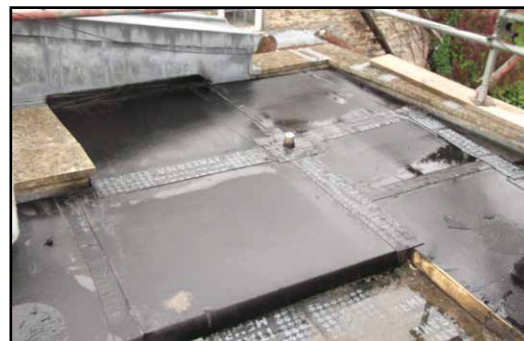
1. Installation of new insulation boards
2. New integrated gutters were created due to the increased thickness of insulation
3. Completed application showing the complex geometry of the roof
4. Completed application showing bonding to several different substrates.

The application was carried out in accordance with Belzona Systems leaflet RPA-8 after installation of new felt back insulation boards.
