BELZONA KEEPS THE RAIN OFF THE SHOP FLOOR

Pump shop forklift traffic area

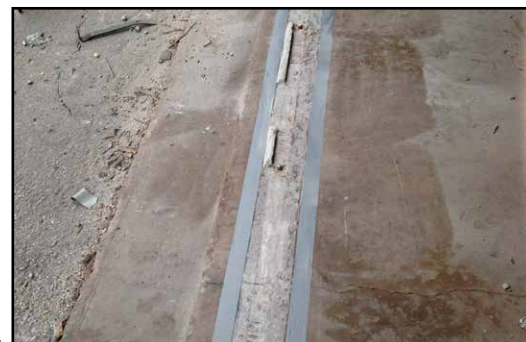
1. Application area being prepared
2. Belzona 4111 being applied to wet out the surface
3. Completed curb using Belzona 4111

Application was carried out using a modified version of Belzona Know-How System Leaflet FPA-1. After proper surface preparation a thin layer of Belzona 4911 conditioner was applied for proper bonding. Belzona 4111 was then used to form the curb.
