BELZONA PROTECTS PELTON TURBINE NOZZLE HEAD

Hydro power plant, Kaunertal, Austria

Pelton turbine with an output of 266MW and head of about 800m. The nozzle head is the leading part of the nozzle assembly which regulates the water flow rate through the turbine.

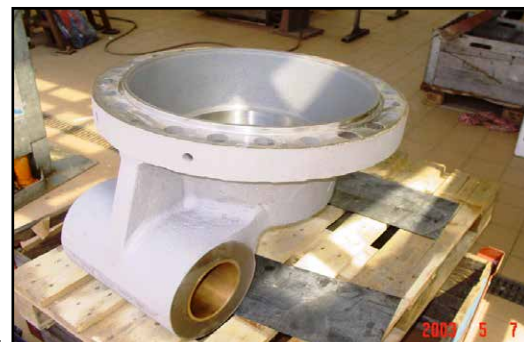
1. Nozzle head after grit blasting
2. Application of Belzona 2141
3. Completed application before installation in May 2003
4. After more than 10 years of operation Belzona 2141 in perfect condition

Application was carried out in accordance with Belzona System Leaflet VPF-2. After preparing surface by grit blasting (80 micron profile achieved) Belzona 2141 system was applied at 1mm thickness.

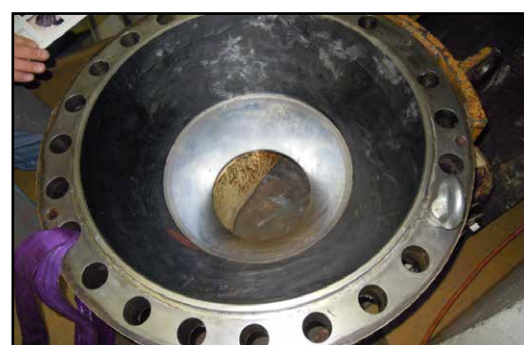
4.

The Belzona system was originally applied in May 2003 and when inspected in February 2014 after more than 10 years in service was found to be in perfect condition.
