BELZONA MOUNTS CELL PHONE ANTENNAS

Attaching steel plates to the top of a water tower for the purpose of mounting expensive new cell phone antennas.

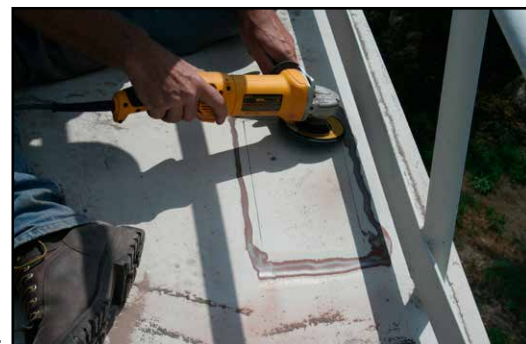
1. Preparing the area 1" wider than the plate all the way around for proper application.
2. Final surface preparation using the MBX Bristle Blaster.
3. Scrubbing it in with a brush.
4. Putting it in place. Job completed.
