BELZONA 1111 (SUPER METAL) MOUNTS CELL PHONE ANTENNAS AT 220'

Mounting steel plates on top of a 220' water tower to mount cell phone radio dishes.

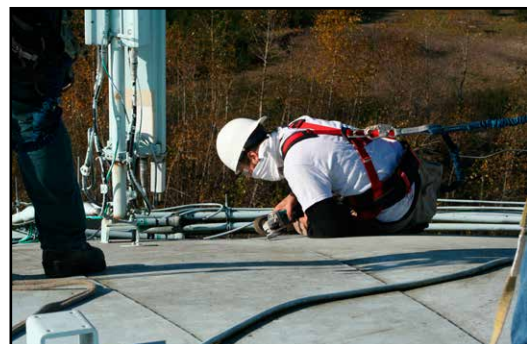
1. Surface preparation
2. Surface ready for application
3. Plate mounted carefully over uneven surface
4. Belzona technical Consultant and the crew after the job is done (Mt. Rainier in the background)

Standard instructions followed as stated in the IFU for the Belzona 1111. As seen in the pictures, some of the mounts were forced to be on uneven surfaces and over weld lines. Special care was taken to ensure the existing paint was removed from the rough surface of the weld without compromising the integrity of the weld itself.
