## CENTRIFUGE ASSET RECOVERY

Centrifuge for process with high levels of brine present in the service causing internal, and external corrosion.

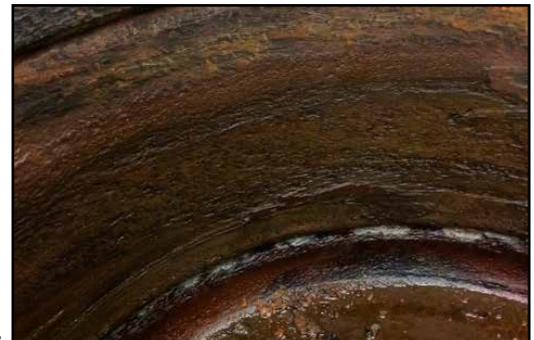
Corrosion of the internals lead to heavy pitting, and wall thickness of the carbon steel. It also led to the complete disintegration of the external water box and it's mount. The customer only had 4-5 days to make repairs or replace it with a new one. Lead time for a new centrifuge was weeks out, so a Belzona Turnkey application was their best option. The exterior was also protected with Belzona 5811, and 5111.

1. View of the interior bowl of the corroded centrifuge shortly after being taken out of service
2. Blasted internal and external substrate
3. Internal bowl coated with Belzona 1321
4. External repaired with Belzona 1111 and Belzona 9341, and coated with Belzona 5811 and Belzona 5111
