BELZONA MAKES THE CABLE RUN

Attaching steel plates to the side of a water tower to run fiber-optic cables up to the cell phone antennas on top.

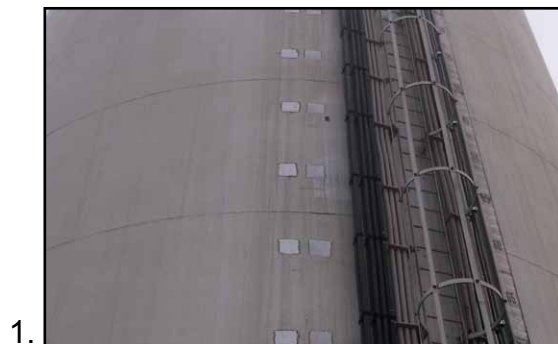
1. Initial preparation complete, paint removed.
2. Partially complete
3. 'Gorilla' tape being used to help the 4"x4" plates stay in place until the Belzona 1161 has cured. Also tape on the threads of the studs so the Belzona 1161 does not get on them.
4. Application is completed.
