INTERNAL COATING FOR CENTRIFUGAL PUMP

Centrifugal pump is used to transport fluids in the waste water treatment plant

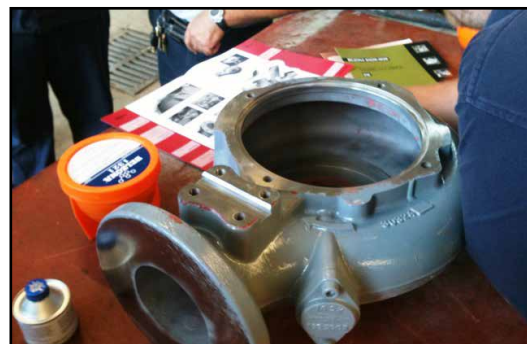
A customer wanted to protect and expand the life of a new pump due to installed at the plant to replace the existing pump which was suffering from corrosion/erosion due to sewage waste.

1. Centrifugal Pump Prior to Application
2. Preparation Complete
3. Application
4. Completed Application
