BELZONA WEATHERPROOFS TWO SUGAR SILOS

Sugar factory, Northern France

Two sugar silos

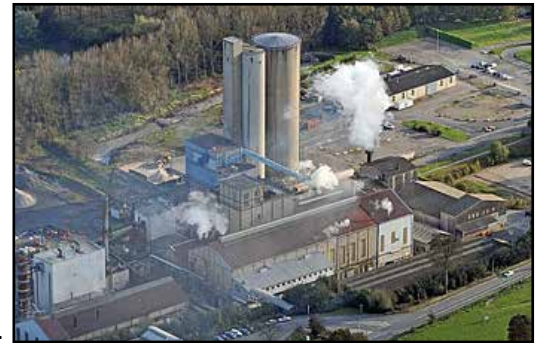
1. General view of the sugar plant
2. Conditioning of the concrete with Belzona 3911
3. On-going application
4. Finished application
