BELZONA 1381: ONE COAT PIPE LINING

Engineering company, Italy

One of the global leaders in the Engineering & Construction and Drilling businesses with a strong bias towards Oil and Gas related activities required internal protection of a pipeline.

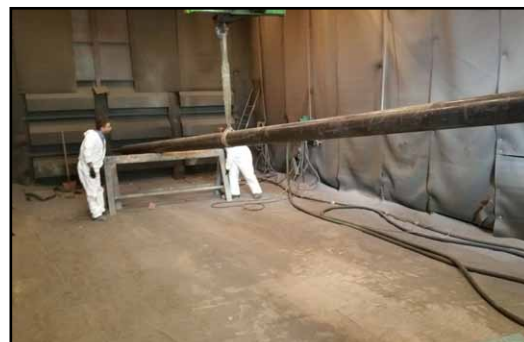
1. Outer view of pipe.
2. Spin blast in action.
3. Completed application, inside view.
4. Completed application, outer view.
