INTERNAL PIPE LINING TRIAL WITH BELZONA

Oil Company, Qatar

Trial application lining small diameter pipe using spin spray equipment.

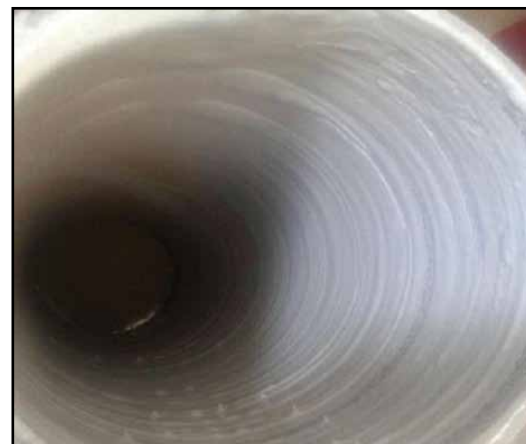
Due to a failure in the application of an alternative product a coating which can be applied to a variety of pipe diameters (4" to 32") was required.

1. Trial of alternative material
2. Belzona Spin spray set up
3. Spin spray in action
4. After cure a cross section cut out for inspection
