BELZONA BONDS RISER BEARINGS ON OFFSHORE PLATFORM

Risers and Riser housings needed protection on a new build Central Processing Facility.

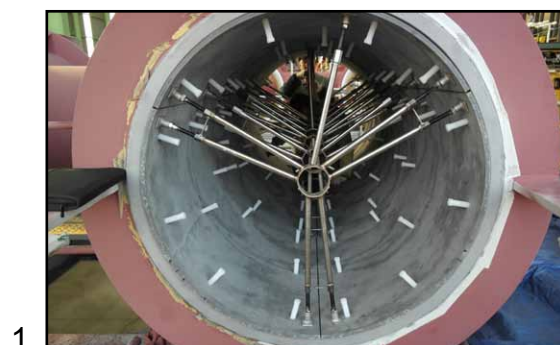
1. Fitting Bearing to Housing
2. Fitting Bearing to Riser
3. Injecting Belzona 1321
4. Riser inserted into Housing

The application was carried out in accordance with Belzona Know-How System Leaflet GSS-9. The Bearings were aligned in place using jigs, straps and injection port bolts. The Bearing had to be jacked to 4mm from the substrate. The seams were then dammed using Belzona 1111. Belzona 1321 was injected through the injection ports. After curing the injection ports were cut off, filled with Belzona 1111, and ground flush.
