## BELZONA SUPERWRAP II PATCHES SEAWATER BULK MEDIA FILTER VESSEL

Seawater bulk media filter vessel on offshore Oil and Gas platform.

Damage to the external part of the bottom of the vessel due to corrosive environment and seawater transported in the vessel.

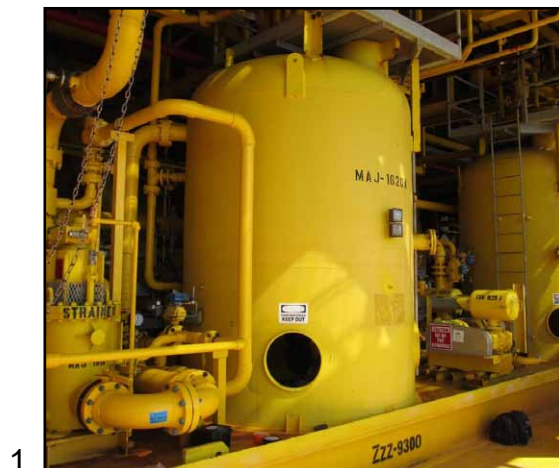
1. Seawater Bulk Media Filter Vessel
2. After abrasive blasting
3. Belzona 1212 used to patch over thin wall area and sealed through-wall defect
4. Belzona Superwrap II applied as per engineered design
