BELZONA PROTECTS CONCRETE FLOOR AGAINST OIL CONTAMINATION

Milton, ON, Canada

Floor in an auction barn.

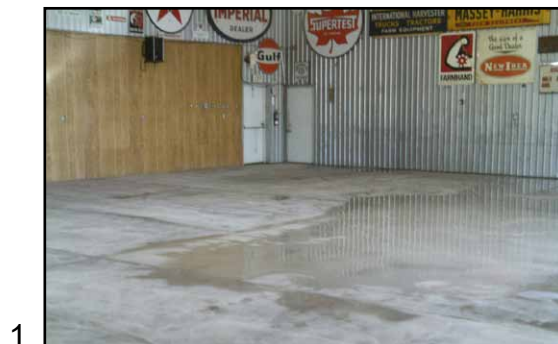
1. Prior to application
2. Preparation in progress
3. Preparation in progress
4. Completed application
