## BELZONA CREATES NON-SLIP SAFETY SURFACE IN FISH MARKET

Fish market, Croatia

June 2016

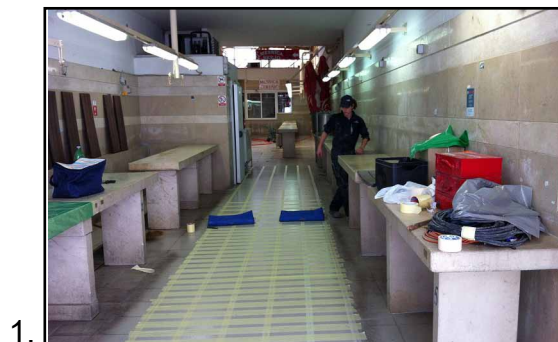
Existing quarry tiles are wet and slippery. During summer season there is plenty of people and there was a risk of slip and fall injuries. Customer was looking for a slip-resistant solution that could be applied without the need to close the market.

1. Condition of the fish market floor, placing masking tape
2. Surface preparation.
3. Application of Belzona 5231 with additional aggregate incorporated.
4. Application completed - situation after washing the floor
