## BELZONA REFURBISHES LOADING DOCK

Business complex, Brisbane, Queensland, Australia

Loading dock and car park of a multi use business complex

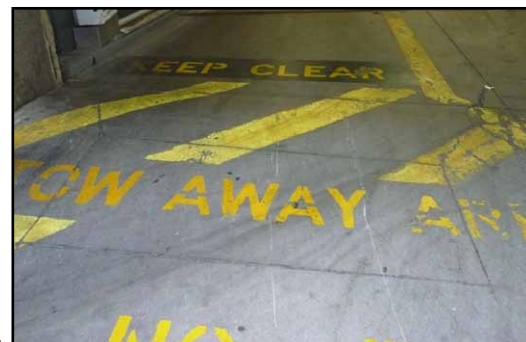
The Loading dock and car park were old and in need of a facelift as all of the original coating had been worn away.

1. The original condition of the floor area
2. Surface preparation in progress
3. A few small touch ups
4. The finished application showing the coated floor and reinstated lines, wording and chevrons
