BELZONA SPRUCES UP STEPS AT A CONDOMINIUM AND PROTECTS FROM UV

Toronto, Ontario, Canada

July 9th, 2015

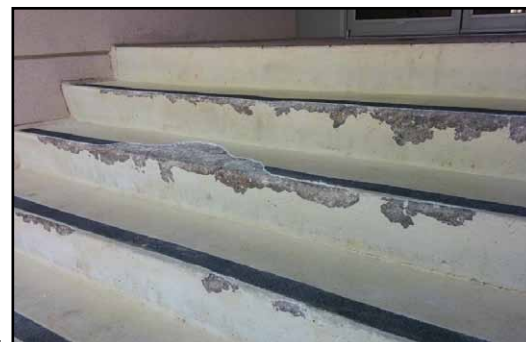
The existing coating that was applied was not UV resistant and had changed color (yellowed) due to exposure from ultra violet light. Additionally removal of ice build up with a shovel had damaged the coating allowing corrosion of the concrete substrate.

1. Damaged steps
2. Damage repaired with Belzona 4131
3. Application of Belzona 5231 and 4411
4. Completed application of Belzona 5233 and 4411 grip system.
