BELZONA REPAIRS DAMAGED TRUCK SCALES

Building materials manufacturer, Croatia

August 2016

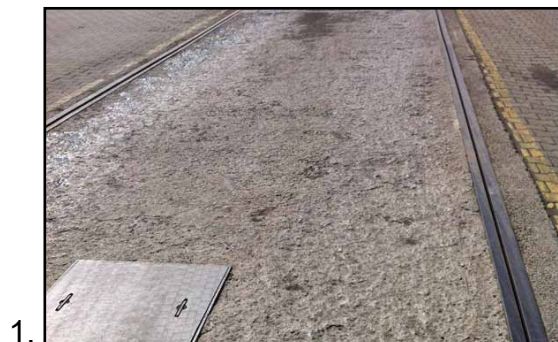
The concrete surface of the scale suffered severe damage due to the heavy traffic, weather conditions and leaking of fuel, oil etc. Customer needed to address this problem, but due to intensive production it was impossible to put the truck scale out of use for more than a day or two. Belzona offered to repair the most damaged parts of the scale (where the reinforcement bars are exposed), as a first phase, with possibility to resurface the whole scale in the next phase.

1. Damaged truck scale - overview
2. Detailed view on one of severely damaged areas
3. Application in progress
4. Completed application
