BELZONA PROVIDES NON-SLIP SURFACE TO TRANSFER ROLLER

Transfer rollers used to move newly formed boards as part of the production line at a particle board plant.

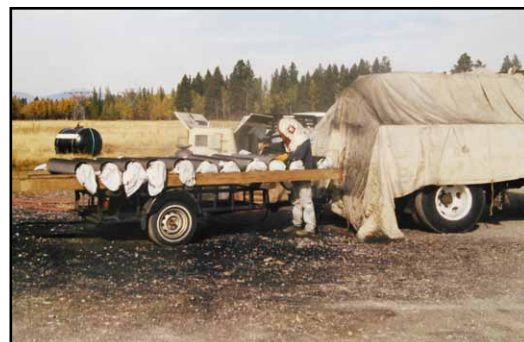
1. Achieving a proper blast profile.
2. Belzona 9111 to clean and degrease before and after blasting.
3. Transfer rollers curing after coating and aggregate applied.
4. Transfer rollers installed and keeping the line going.
