BELZONA SEAMLESS ROOFING FOR SUBSTATIONS

CUSTOMER
Refinery, UK

APPLICATION DATE
2009

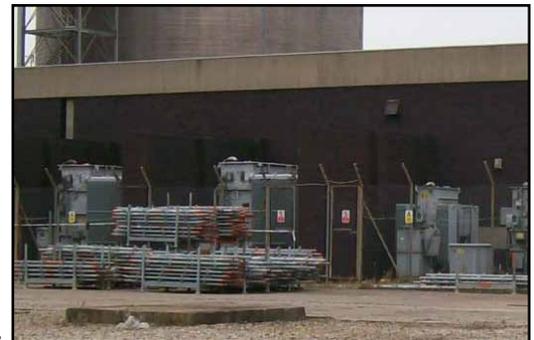
APPLICATION SITUATION
Flat asphalt roofs over plant electrical substations. The roof illustrated here was the first of many refurbished on site and comprised 18mm chippings over an asphalt deck totalling 260 square meters with extensive lichen and moss growth.

- PICTURES**
1. Substation flat roof
 2. Asphalt de-chipped
 3. New vent detail of finished system
 4. Completed roof fully protected with Belzona 3131

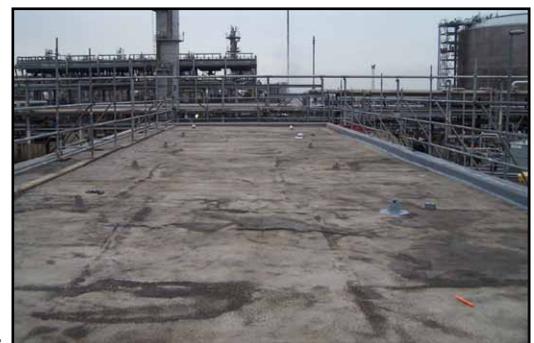
2.

SUBSTRATE
De-chipped asphalt
