## BELZONA LEADING EDGE APPLICATION ON A WIND TURBINE

Wind Farm, Iowa, USA

Leading edge of a wind turbine.

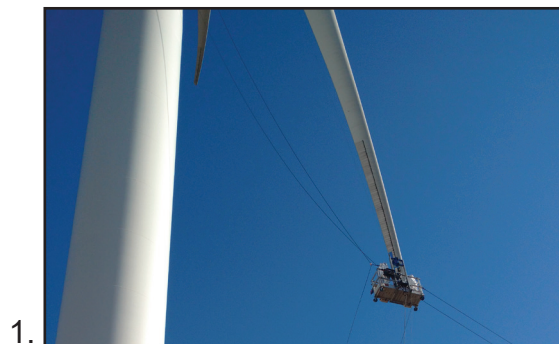
1. Contractors set up in the cable elevator at the turbine tip.
2. Surface preparation, LEP outline, and the coating ready to fill pitting and then coated
3. All of the LEP area now coated and protected with Belzona 1341.
4. Blade ready to be back in service with Belzona 1341 Blue.
